APRIL, 1964

THE NAVAL AVIATION SAFETY REVIEW

MOMENT OF TRUTH, lost
tail rotor thrust
PROGRESS REPORT, a current
launch problem

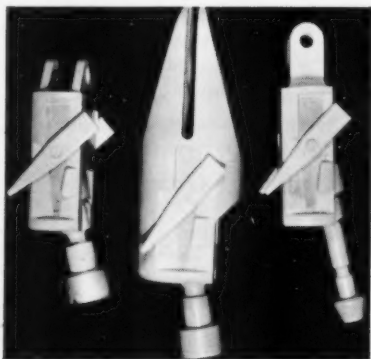
Typical integral deck holdback retainers and mispositioned tension bars: (left to right) A-4, F-4B, F-8: note flag positions.

● **Tension Bar Mispositioning.** It was discovered that despite design changes and operational evaluations, it was possible to misposition a tension bar in either the deck holdback terminal or aircraft fitting. This condition, aggravated frequently by darkness and foul weather, defied visual detection. Often, the tension bar would seat itself during the tensioning sequence, permitting the aircraft to lurch forward sufficiently to drop the launching bridle or pendant, with obvious consequences. Occasionally, application of shuttle force caused the bar to eject itself from the fitting entirely.

As added protection against mispositioning, the fitting handle, held in the OPEN position by an unseated tension bar, exposes a brightly-painted (Da-Glo) area of the fitting and serves to alert catapult hookup crews to the condition.

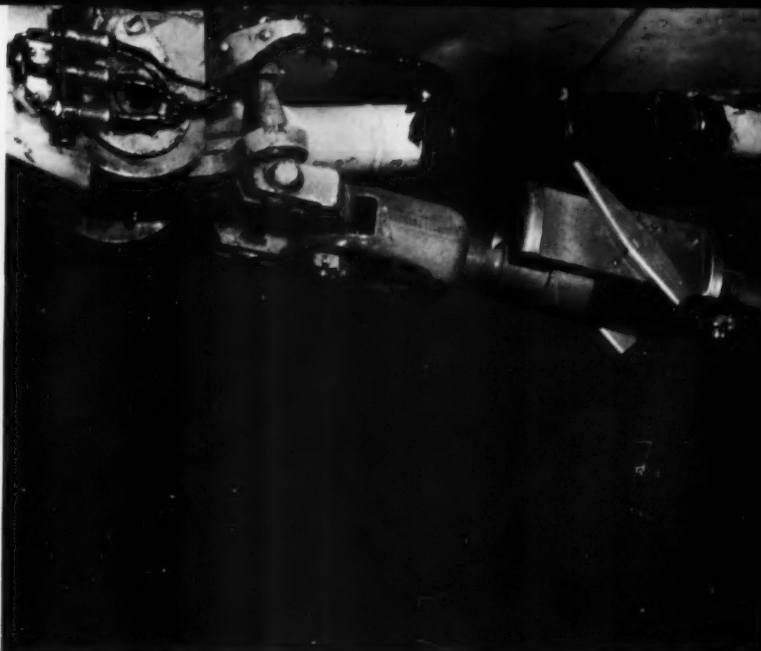
Mispositioned tension bar in integral deck holdback retainer of A-4 aircraft.

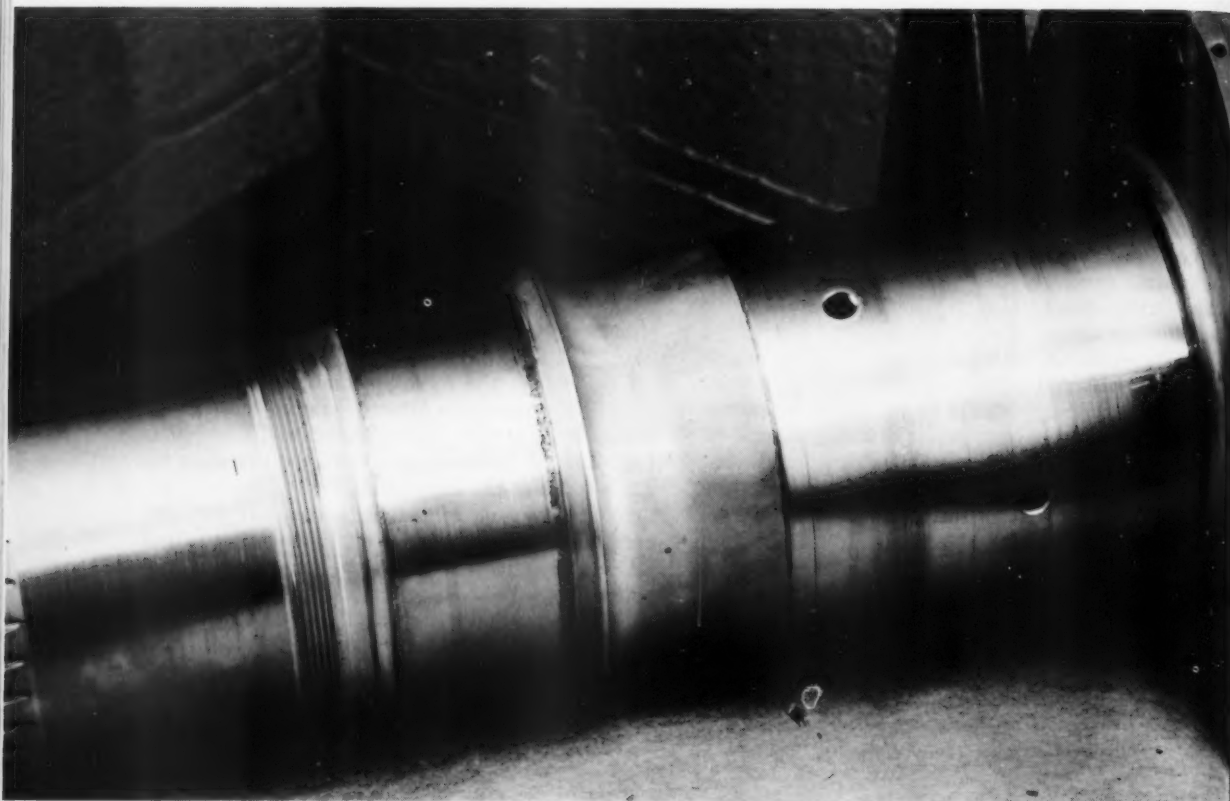
Scoring of R3350 propeller shaft resulted from oil starvation. Note areas adjoining oil holes.

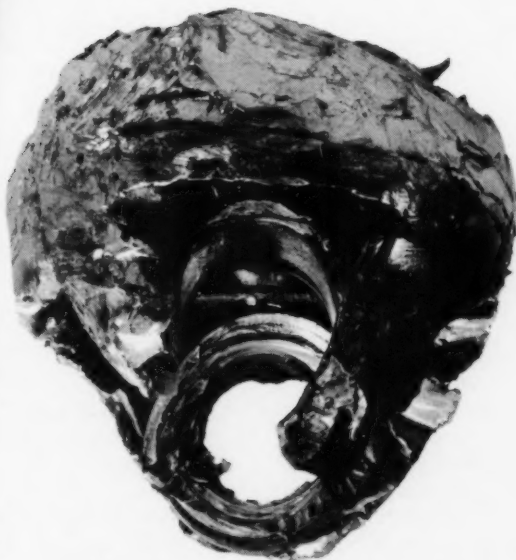
R1820 piston failure precipitated by oil starvation.

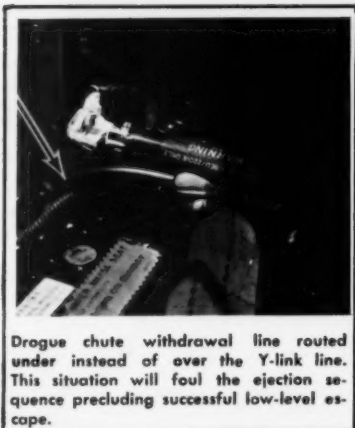
Pax River — A preflight checklist used here triggered the discovery of a misrigged Martin-Baker seat drogue chute withdrawal line. This maintenance goof was found on an F8C just out of major inspection with all paperwork completed and signed off.

Drogue chute withdrawal line routed under instead of over the Y-link line. This situation will foul the ejection sequence precluding successful low-level escape.
